Case 241 : Narrative

| Case Vehicle (A): 1999 Subaru | Vehicle (B): 1987 Ford |
| Type: Legacy Outback, 4-door station wagon | Type: Mustang LX, 2-door sedan |

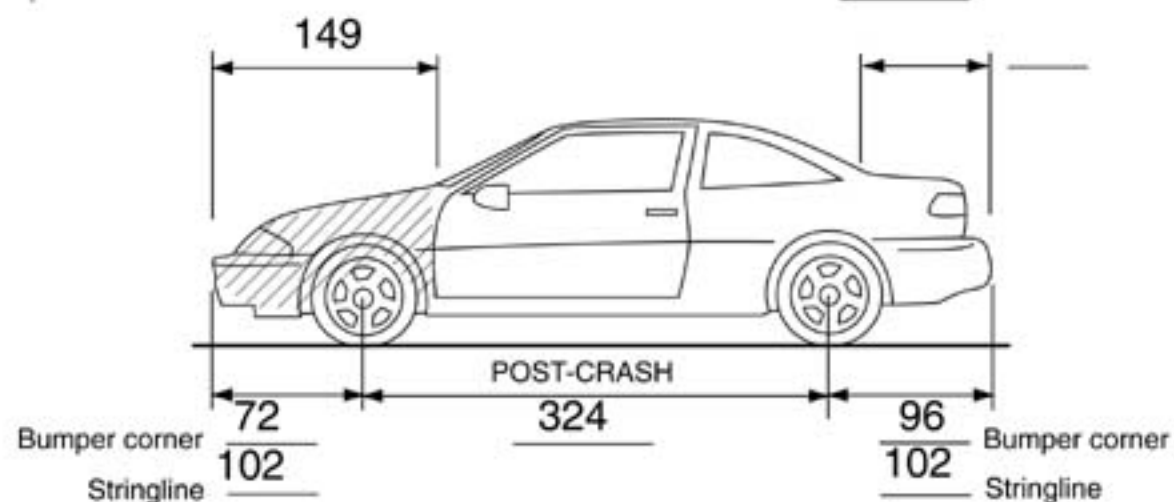
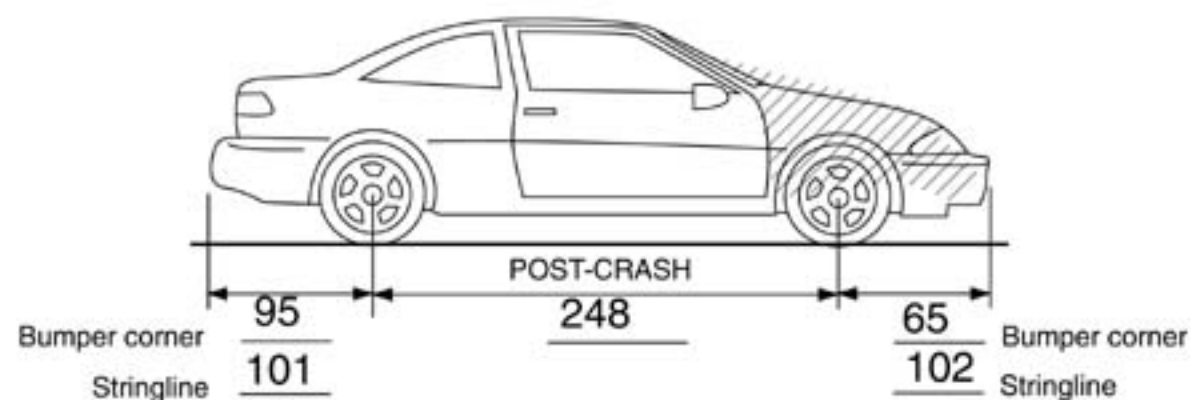
direct damage is 150
maximum crush is 27

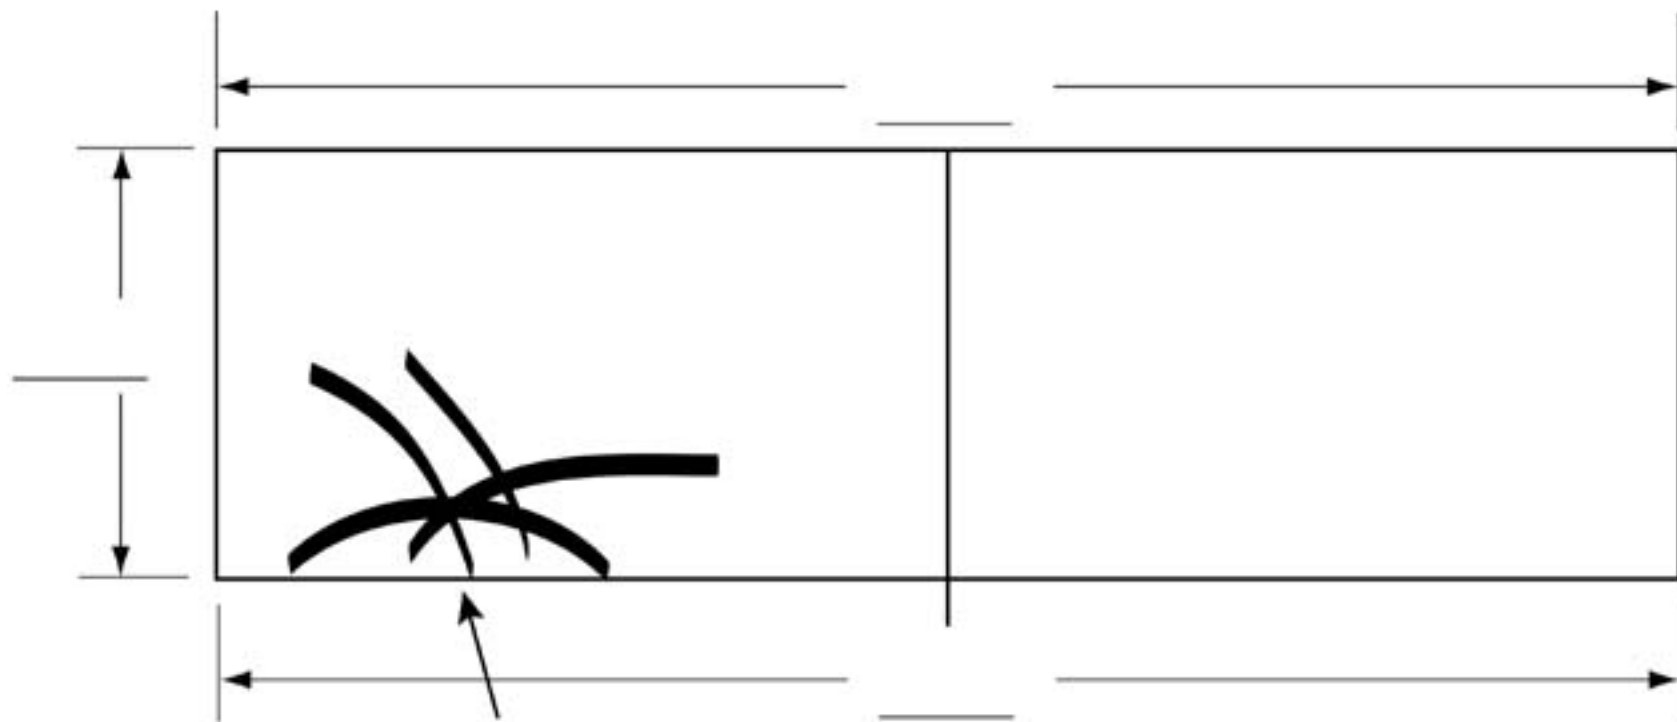
COWL DEFORMATION
CAUSED CRACK IN WINDSHIELD

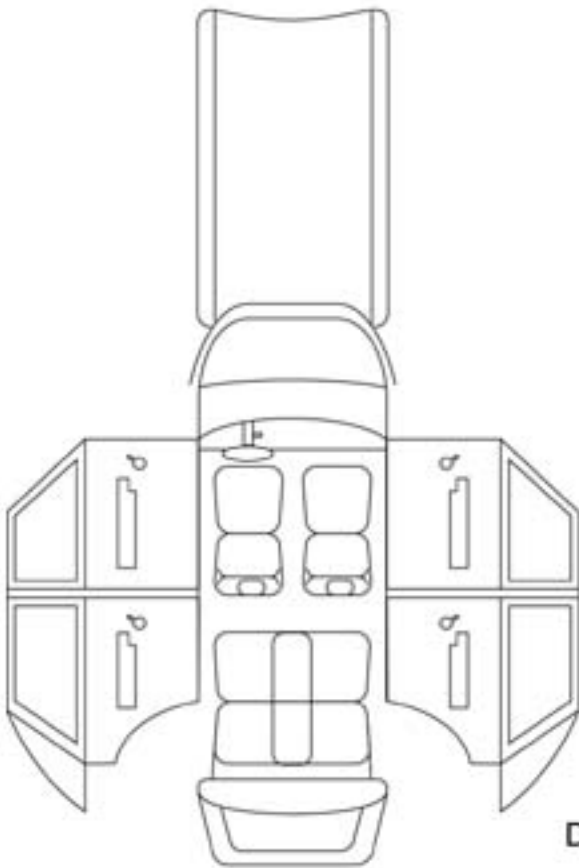
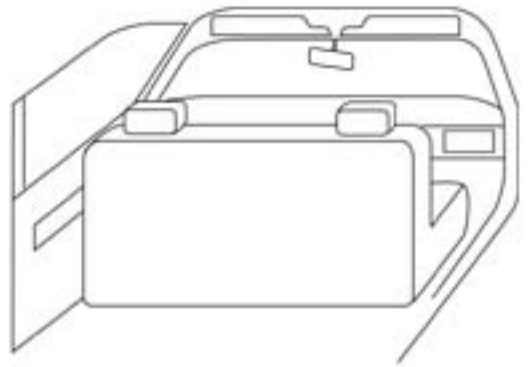
DR BELT: belt positioned high on B-pillar, marks on D-ring and shoulder-belt webbing

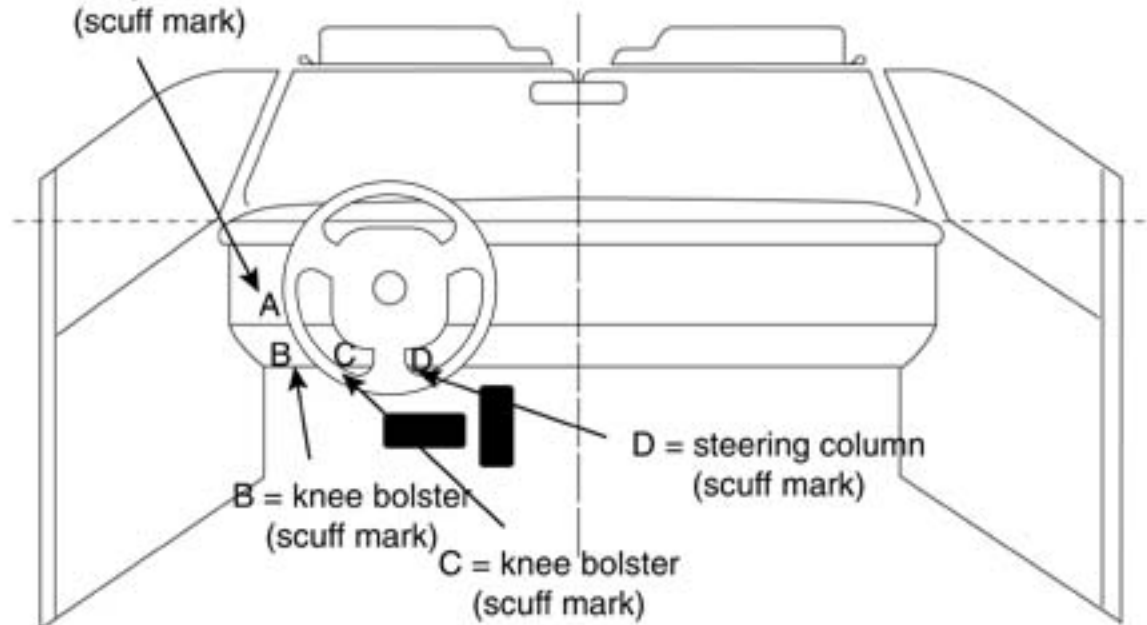
A = mid portion of IP
(scuff mark)

D = steering column
(scuff mark)

B = knee bolster
(scuff mark)
